## Landslide protection of the historical heritage in Odessa (Ukraine)

**Abstract** This study focuses on the specifics of modern geological conditions and deformations of landslide-affected slopes within the historical center of the city of Odessa. Landslide protection was developed in the 19th century and during 1960s on adjacent coastal areas, according to urban planning and landslide protection plans. The historical center was formed around the Odessa port and includes several unique architectural monuments such as the 142-m-long Potemkin Stairs, Primorsky Boulevard, and the Odessa Opera Theater. Architectural and urban planning designs in the city include landslide protection and preventive measures. Results of landslide studies show that landslide development along the Odessa coast is influenced primarily by tectonic movements and the heterogeneity of the geological substrata. All historical and contemporary protective and preventive landslide measures maintain their engineering geological integrity and effectiveness despite the differences in time of their construction and design.

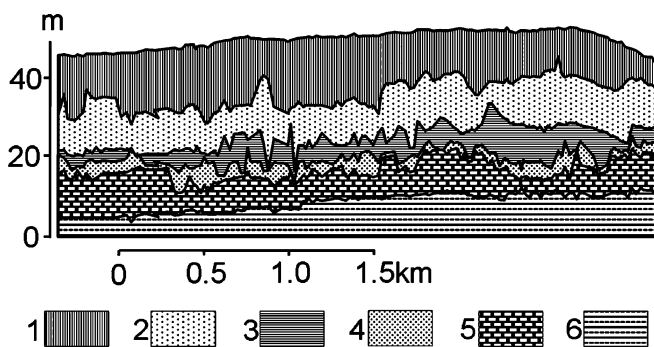
**Fig. 2** Geological cross-section (south–north) along the drainage gallery of the first stage of the landslide protection in Odessa (for the location of the landslide protection complex, see Fig. 3). 1 Pleistocene loess, 2 Pleistocene loess-like loam, 3 Upper Pliocene red clay, 4 Alluvial sediments on Pontian limestone, 5 Pontian limestone, 6 Meotian clay

The stratigraphy and lithology of the landslide-affected slope includes Meotian, Pontian, Middle–Upper Pliocene, and Pleistocene formations (Fig. 2). These formations gently dip in a southerly direction that is approximately perpendicular to the coastal slope

orientation. Meotian clays are exposed along Odessa Bight above the high sea level mark; these clays are overlain by Pontic limestones, sandy and clay deposits of Upper Pliocene and Pleistocene loesses (Zelinsky et al. 1993a). The prevailing type of deposits is clay; less distributed are sandy and cemented carbonate deposits. All deposits are characterized by heterogeneous composition, lithology, and spatial distribution of their physical and mechanical properties. For the period from 1797 to 1964, the coast of Odessa experienced more than 250 different landslides of various types (Zelinsky et al. 1993a). By 1964, Odessa started the implementation of new landslide preventive and protective measures that included slope grading, drainage system, and reinforcement of the lower parts of the landslide-prone coastal areas by artificial beaches that provided necessary loading mass to prevent rotational landslides.

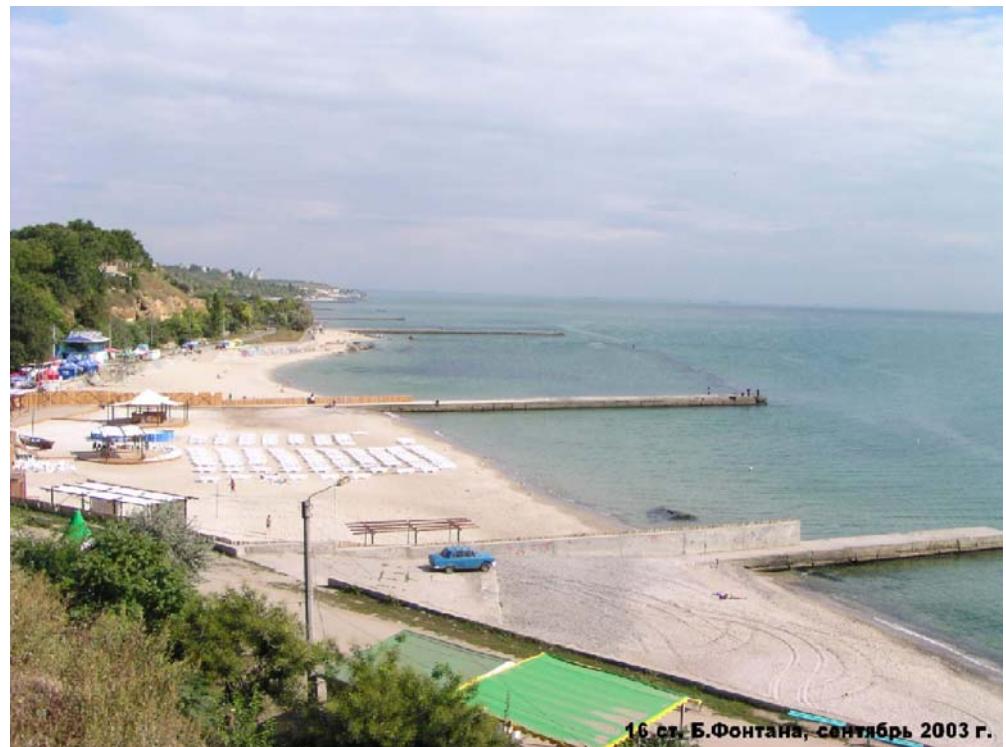
**Fig. 4** View of the segment of the landslide protection from the second stage (1970s)

The new stage of the landslide protection in Odessa started in 1964 between the Lonzheron and Arkadia capes (first stage) and later (second stage) in 1970s between Arkadia and Bolshoi Fontan (Fig. 3). The design of this protective measure took into account specific geological characteristics of the Odessa coast and consisted of the following elements (Fig. 4):

- Artificial beaches and structures (jetties and wave breakers) that were designed to keep beach material intact and to prevent further wave erosion;

- Grading landslide-prone slopes to reduce their gradient and tangential stresses in rocks and embankments;
- Drainage of groundwater from the Quaternary aquifer using vertical drains; drainage of the Pontian aquifer using horizontal galleries and passages;
- Constructing surface storm drain system and planting vegetation.
